# HSEQ ALERT-OSB-89-Diesel Spill BOTLEY DIESEL SPILL INCIDENT

OSBORNE

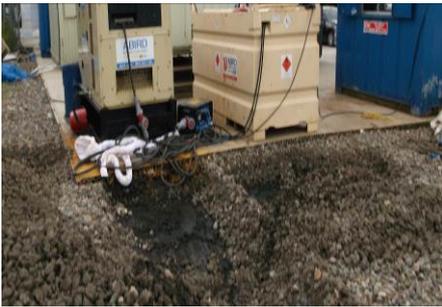
Diesel spill at rear of generator

The generator was fed by a fuel bowser, and both were independently banded to 110% capacity. Early indications are that there was a fault with the change-over valve of the generator, which resulted in diesel building up pressure in the return pipe causing the pipe to fail and diesel to be continuously discharged into the generators bund.

The bund of the generator didn't have sufficient capacity to accommodate the capacity of diesel from the fuel bowser and therefore flooded, causing diesel to leak into the ground of the surrounding area.

The exact cause of the technical failure is being ascertained with our plant supplier. Early recommendations are that micro switch generators which automatically cut off power in the event of a spill **SHOULD** be used when generators with additional external tank feeds are used.

These are to be checked and addressed across all sites immediately.

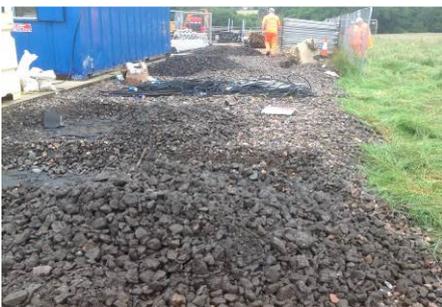
Diesel spill locations

- The spill was immediately contained by switching off the source of the diesel
- Spill kits were applied for initial clean up
- A fitter attended site to repair the faulty generator
- Trial holes were undertaken to ascertain the extent of the spill
- A review is being undertaken to determine whether there has been any impact on sensitive receptors
- A specialist clean-up contractor is removing the contaminated material for appropriate disposal

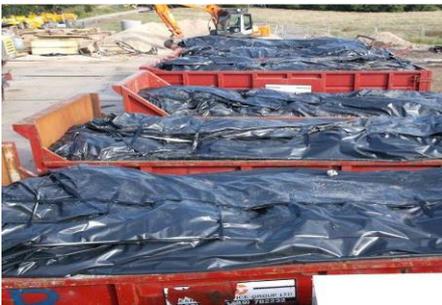
Remedial works in progress

The investigation is also considering whether additional bunding is required.

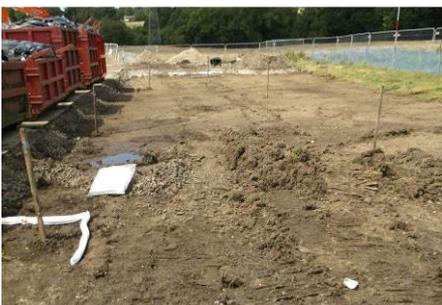
Cleaned area
